EXPLOSIVE TRUTHS

THE PERILS AND THE CATASTROPHIC POTENTIAL OF LNG

Prepared by Equal Routes for Greenpeace Germany

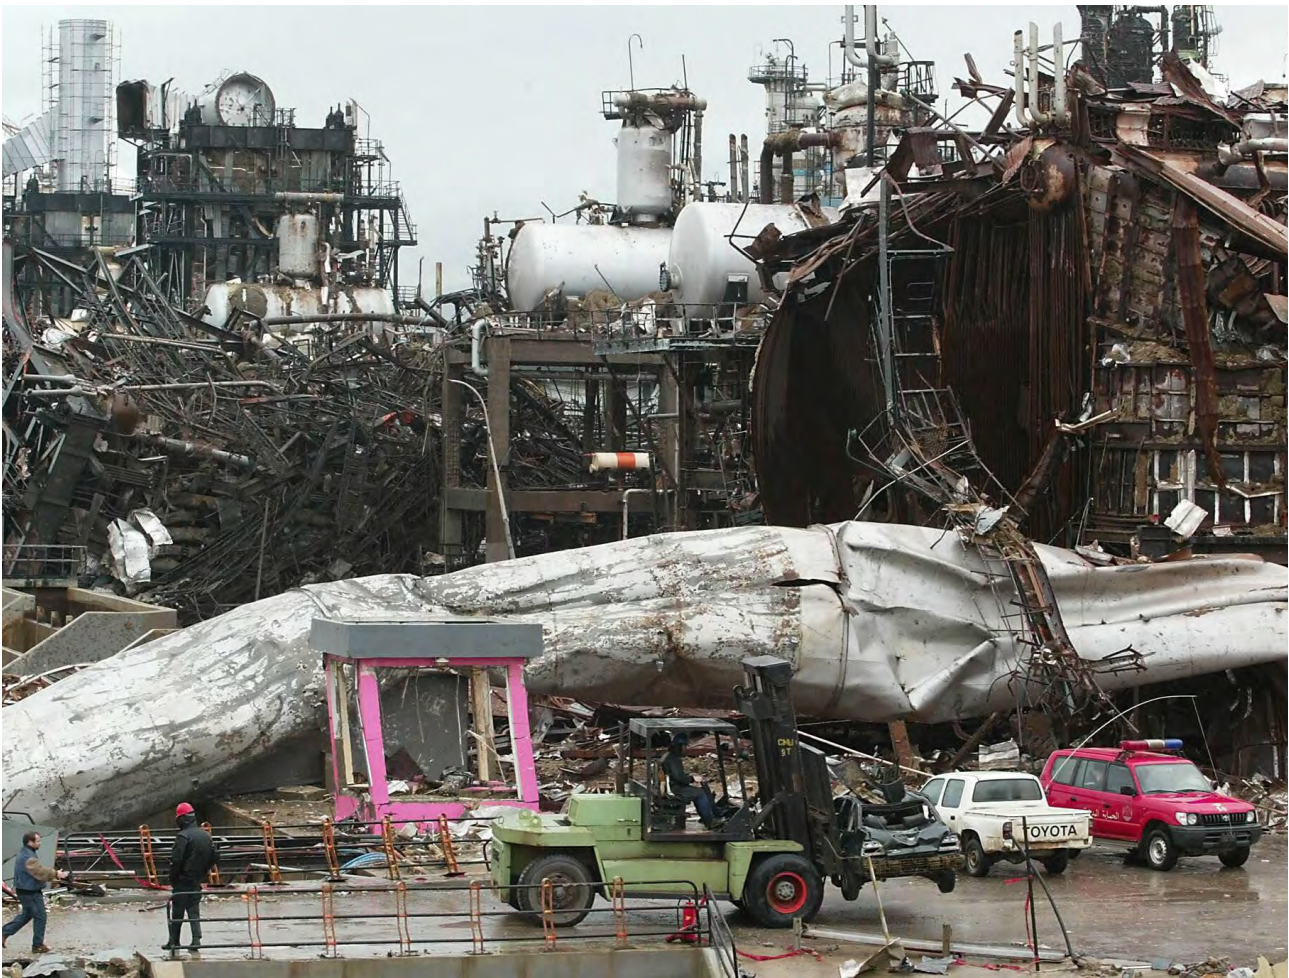
Skikda, Algeria – The LNG plant in Skikda stands in ruins following a devastating explosion on January 19, 2004. The blast, Algeria’s worst industrial disaster since independence, claimed at least 27 lives, injured many others, and severely impacted the nation’s gas-dependent economy.

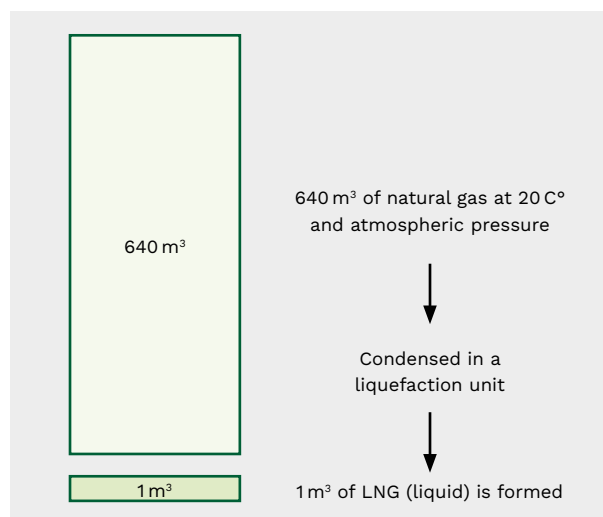
Figure 1: Comparison of fossil gas and LNG volumes throughout the liquefaction process.

LNG is produced by cooling fossil gas to -162°C (-260°F), which turns it into a liquid form. LNG is a cryogenic liquid¹ stored at its boiling temperature. When the pressure remains constant, the temperature can also stay stable. In its liquid form, LNG occupies less than 1/600th of the volume of fossil gas in its gaseous state (Figure 1). When exposed to normal atmospheric temperature, LNG will boil and release extremely cold gas. As a result, LNG is highly flammable and extremely cold, primarily composed of methane with a small percentage of other hydrocarbons. Even small amounts of LNG can expand to create large volumes of gas.

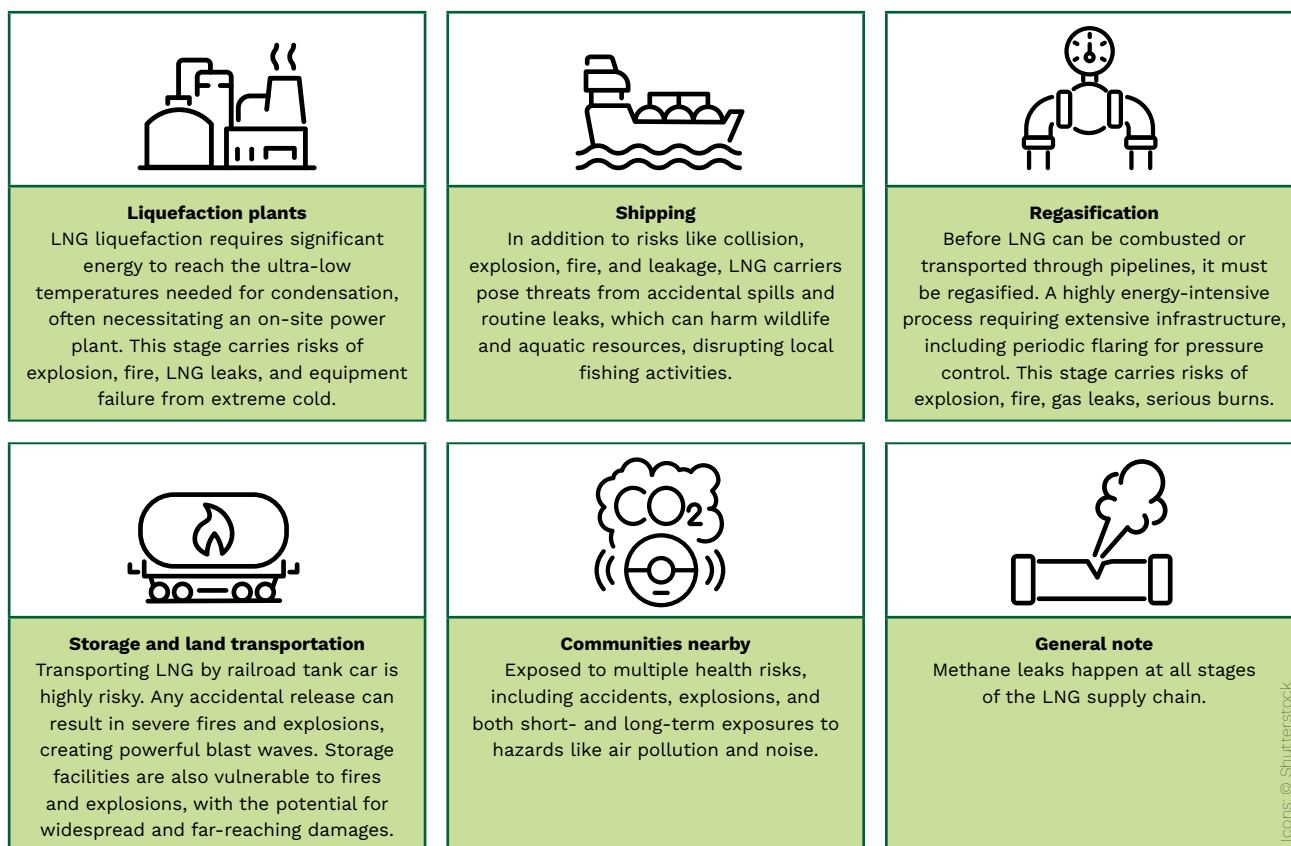
Figure 2: Risks across the LNG Supply Chain.

LNG facilities are highly capital-intensive and include liquefaction plants, tanker ships and trucks, regasification terminals, and inland storage equipment (Figure 2). These facilities pose public health risks to nearby communities by releasing toxic air pollutants such as carbon monoxide, nitrogen oxides, sulfur dioxide, and volatile organic compounds. Communities nearby LNG facilities are overburdened by pollution and environmental impacts (Heureaux-Torres, Chang, Donaghy 2024).

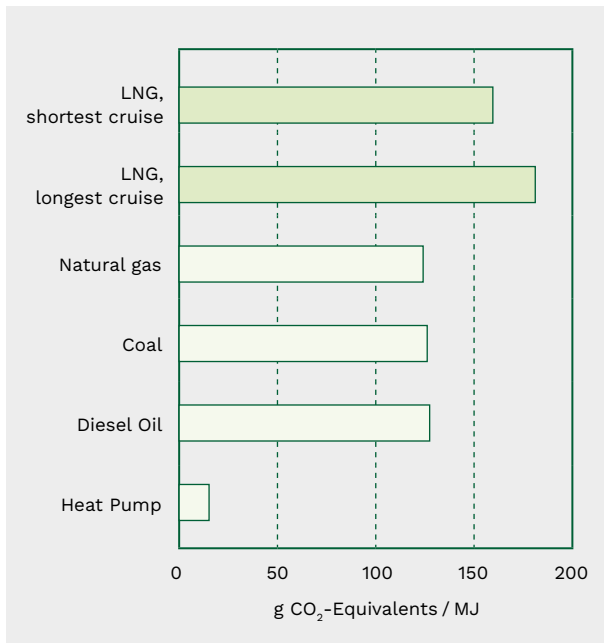
Figure 3: Full lifecycle greenhouse gas footprint for LNG for both short and long cruises compared with the use in the US of coal, diesel oil, fossil gas, and electric-power ground-source heat pump powered by the average European electric grid.

The combined energy demands of safety requirements including refrigeration, venting, leakage, flaring, and transport make LNG more energy-intensive than conventional fossil gas (Figure 3). A recent analysis suggests that large-scale LNG exports from the United States could increase global greenhouse gas emissions, driven both by the additional energy burden and the expansion of fossil fuels on the global market (Howarth 2024). Moreover, LNG tanks require evaporative cooling, which involves venting vaporized methane to maintain low temperatures and reduce explosion risks. Although some of this gas can be captured, for instance in larger LNG carrier vessels, leaks remain unavoidable.
